**REPORT AND VALUATION
ON
“DOLPHIN COVE NEGRIL”
POINT (PART OF SECTION C)
LUCEA
HANOVER**

REPORT AND VALUATION

| ITEM | DESCRIPTION | PAGE |
|--|--|---|
| DATE OF REPORT | : OCTOBER 2014 | 14 |

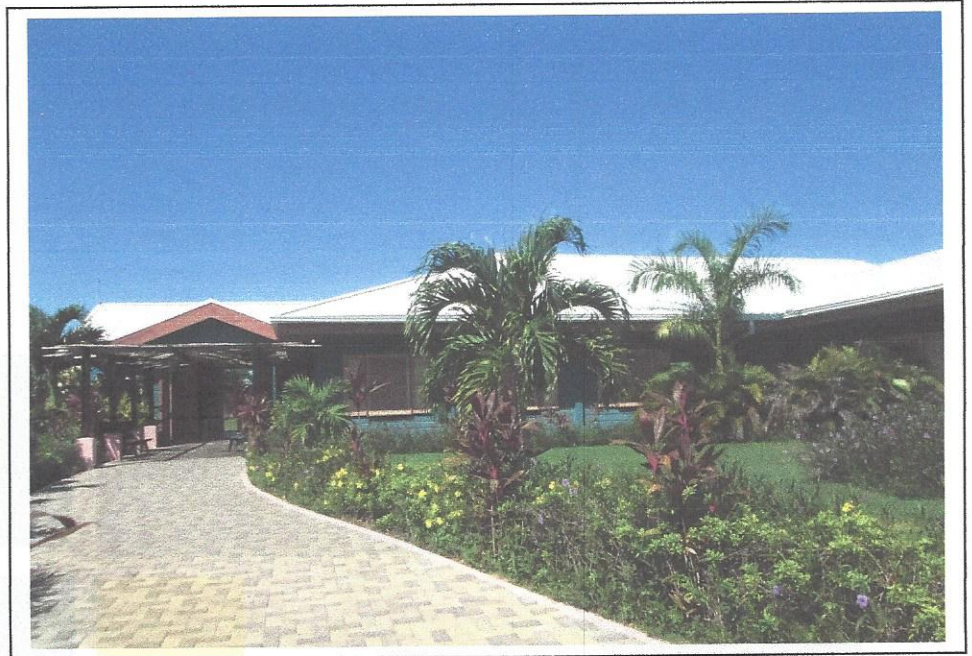
BUILDING # 1 Taken (12/10/2014)

Building # 1 – Administrative Office/Gift Shop

This single storey building is disposed over a gross floor area of approximately **491.11 m² (5,286.26 ft²)**. It consists of a receptionist area, sitting lounge, gift shop, general office, security camera observation room, bathroom, video department and storage.

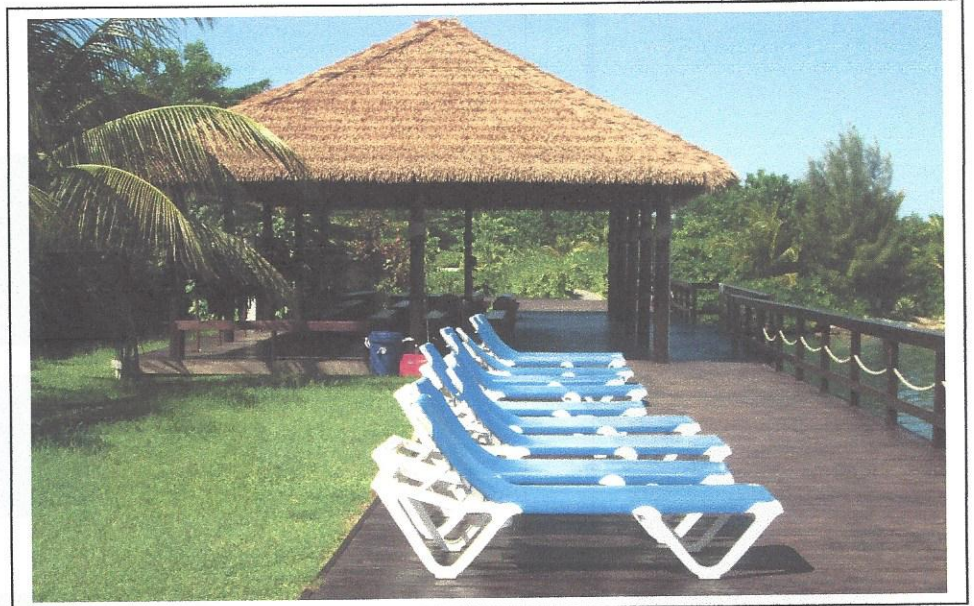
BUILDING # 3 Taken (12/10/2014)

The "Palapa" area is located along a dolphin observation area and is accessed by a boardwalk suspended on wooden posts along the bay. This area is used for training and orientation for guests.

Building # 3 – Palapa

This is an open-shed type structure disposed over a gross floor area of **108.14 m² (1,164.00 ft²)**. It consists of a large area used for training, observation and orientation.

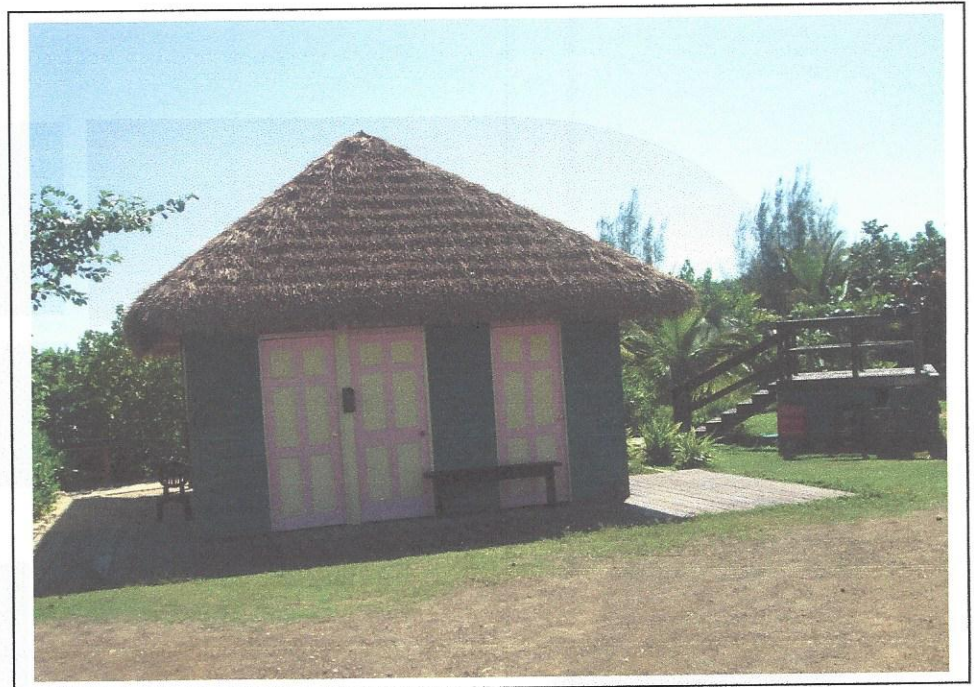
BUILDING # 5 Taken (12/10/2014)

Building # 5 – Changing Room

This building is disposed over a total gross floor area of **44.31 m² (477.00 ft²)**. It consists of changing areas and an open shed area used for dining.

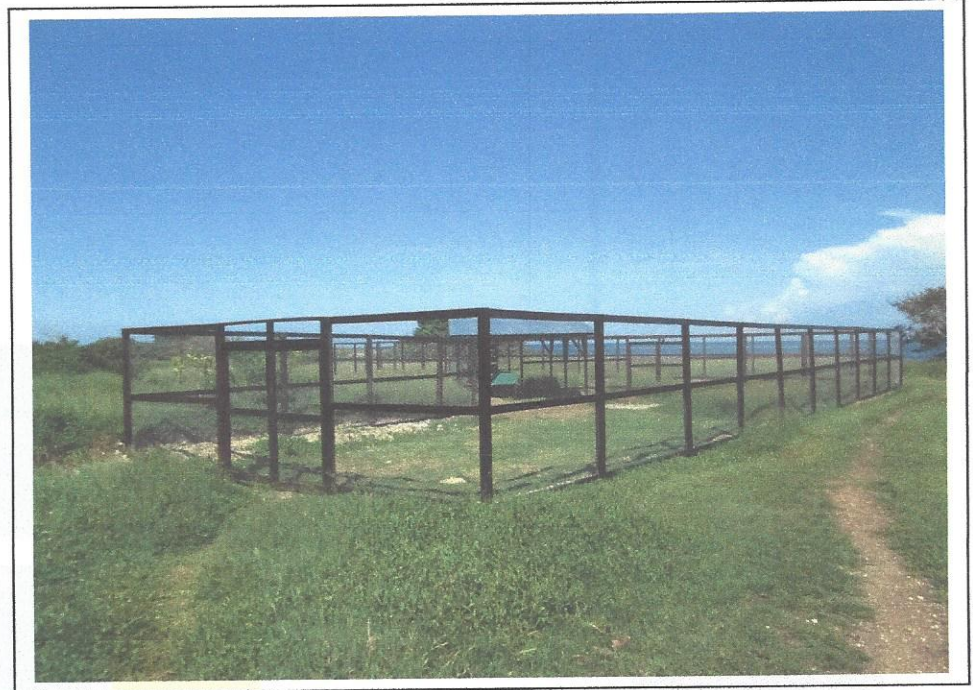
OSTRICH PEN Taken (12/10/2014)

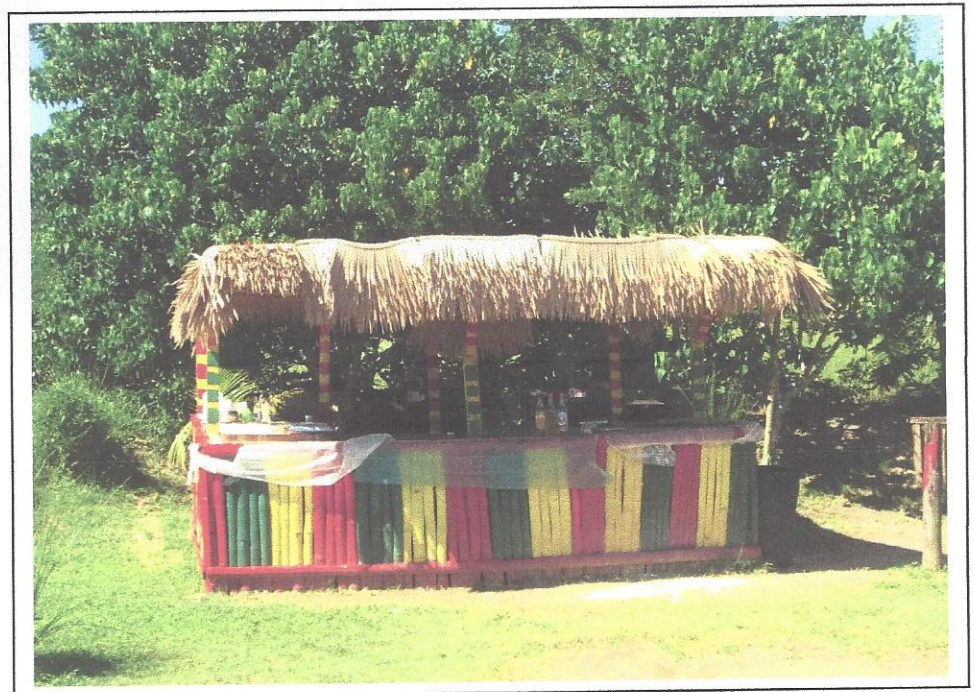
BARBEQUE HUT Taken (12/10/2014)

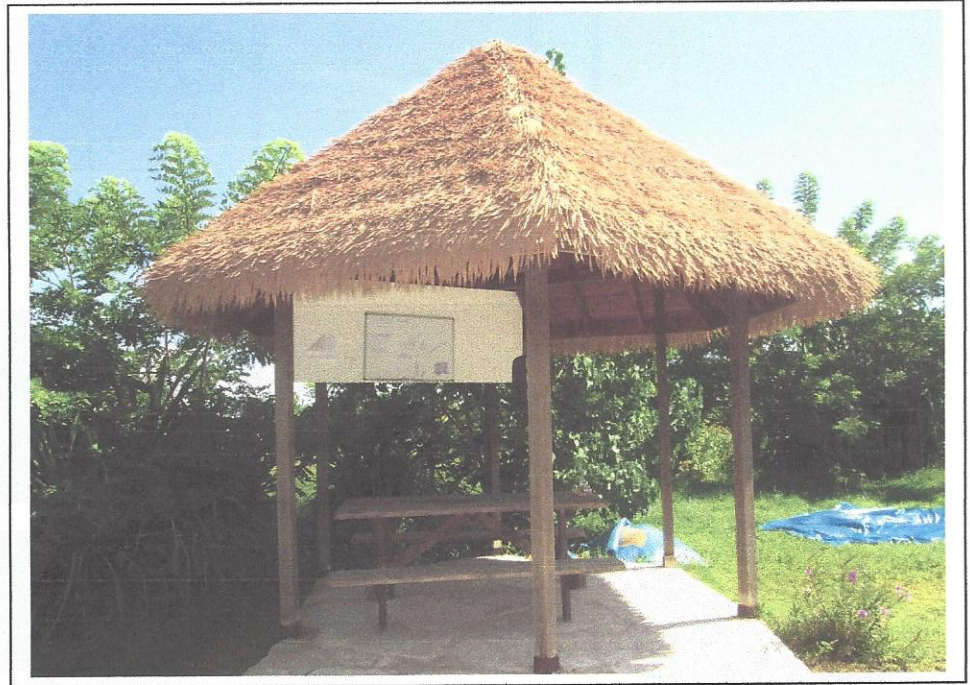
GAZEBO Taken (12/10/2014)

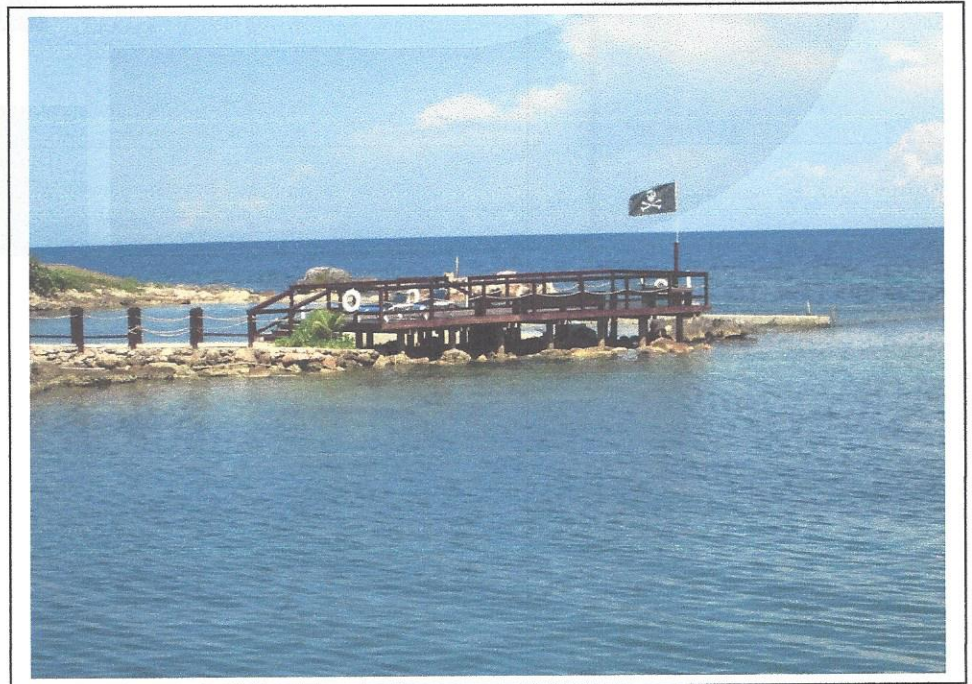
SHARK SHOW DECK Taken (12/10/2014)

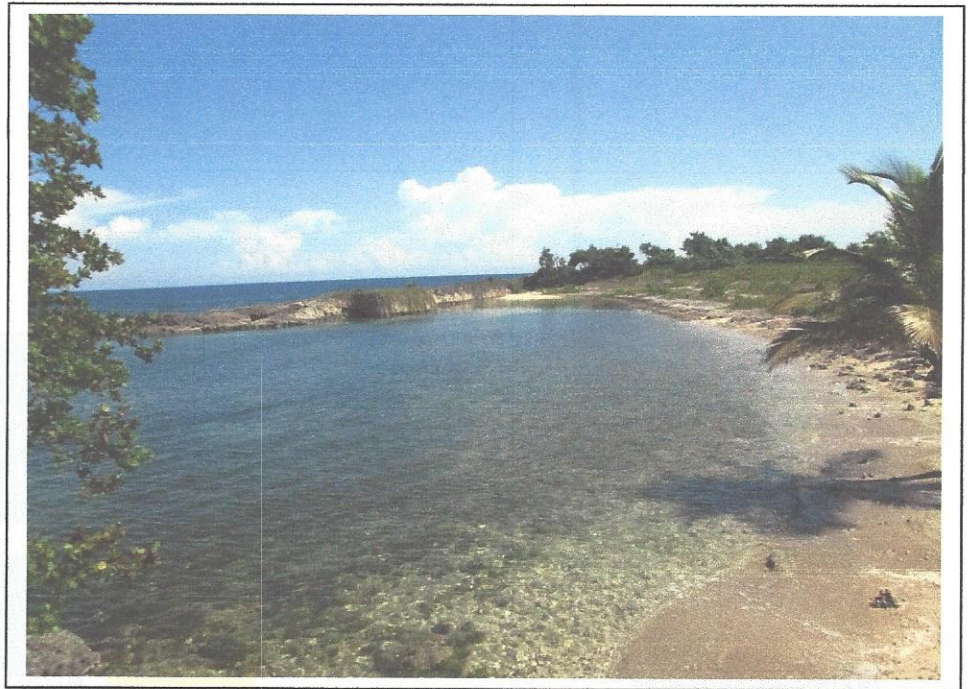
Several breakwater groins have been established to define the used areas; in addition, there is an area that is well suited and is reserved for the development of a beach area.

PROPOSED BEACH Taken (12/10/2014)
